National Transportation Safety Board

Marine Accident Brief

Barge Breakaway and Contact with the Emsworth Locks and Dams

Accident type	Contact	No. DCA18PM011
Vessel names	<i>Dashields, Emsworth, and 27 barges</i>	
Location	Ohio River, mile 6.2, ¹ Emsworth, Pennsylvania 40° 30.18' N, 080° 5.35' W	
Date	January 13, 2018	
Time	0630 eastern standard time (coordinated universal time – 5 hours)	
Injuries	None	
Property damage	\$12.5 million, including salvage, repairs, and lost vessels	
Environmental damage	Unknown amount of coal and cement released into the Ohio River	
Weather	Overcast with light snow, visibility 2 miles, winds 14 mph from the north, air temperature 15°F, water temperature 32°F	
Waterway information	The Ohio River extends 980 miles from the confluence of the Monongahela and Allegheny rivers at Pittsburgh, Pennsylvania, to Cairo, Illinois, where it flows into the Mississippi River. On the day of the accident, the river gage height at the Emsworth Dam Lower Pool was 27.04 feet, about 4 feet above flood watch activation. The current was estimated at 5–8 mph.

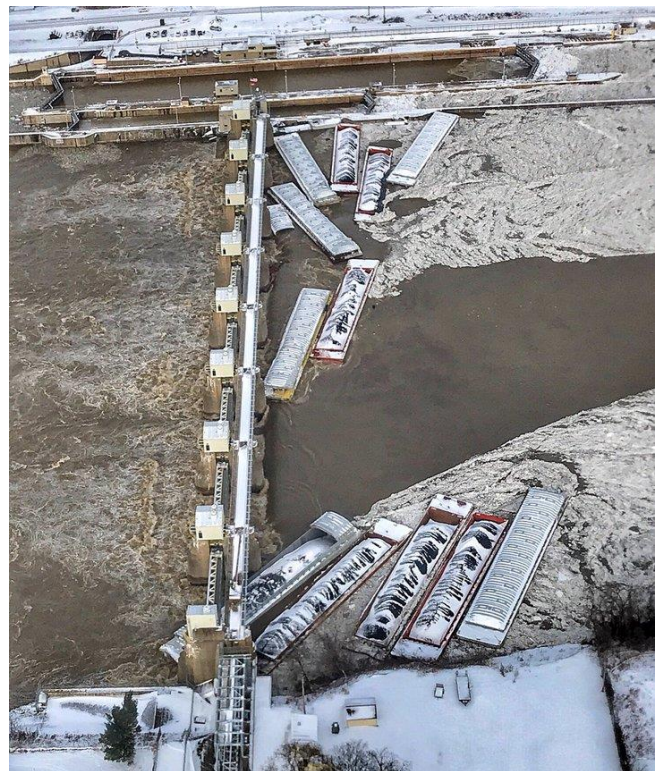
Aerial photo of Emsworth Locks and Dam with breakaway barges (Photo by US Coast Guard)

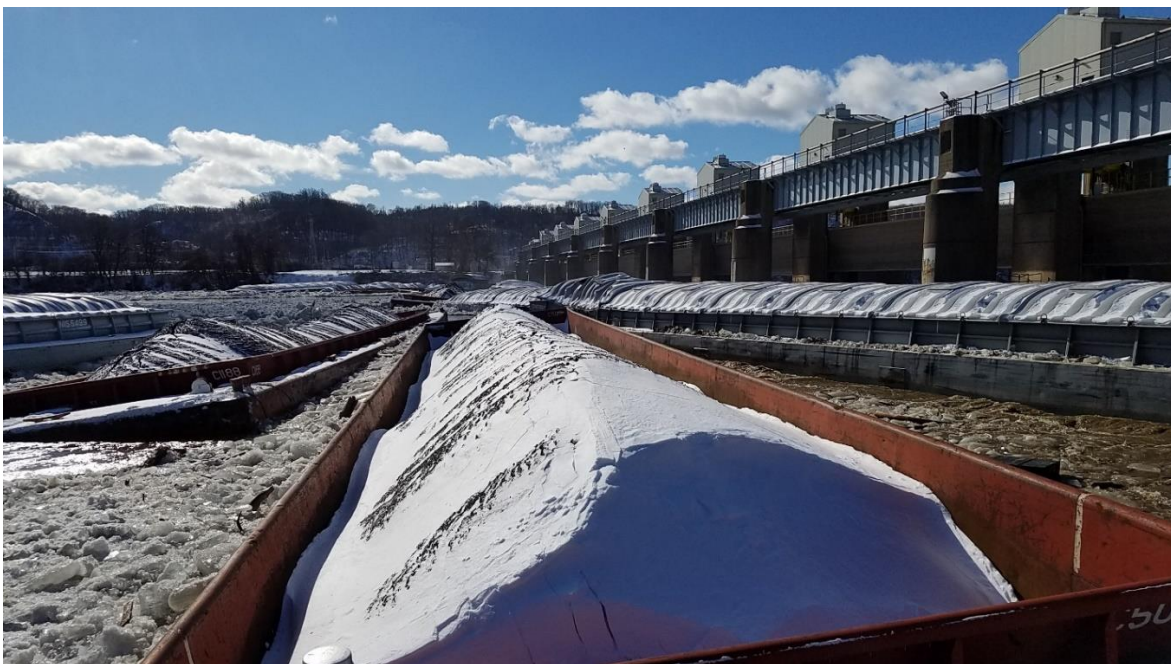
The 25 remaining barges drifted down the Ohio River, and, at 0712, the first of the barges struck the dam located north of Neville Island. Seven barges passed through the dam's open lift gates, two barges sank above the dam, and the rest of the barges lodged in various locations along the dam structure, riverbank, and the area surrounding the dam. One barge floated down the back channel on the south side of Neville Island, hit the dam, and then sank above the dam.

Hopper barges after striking the main channel dam. (Photo by Coast Guard)

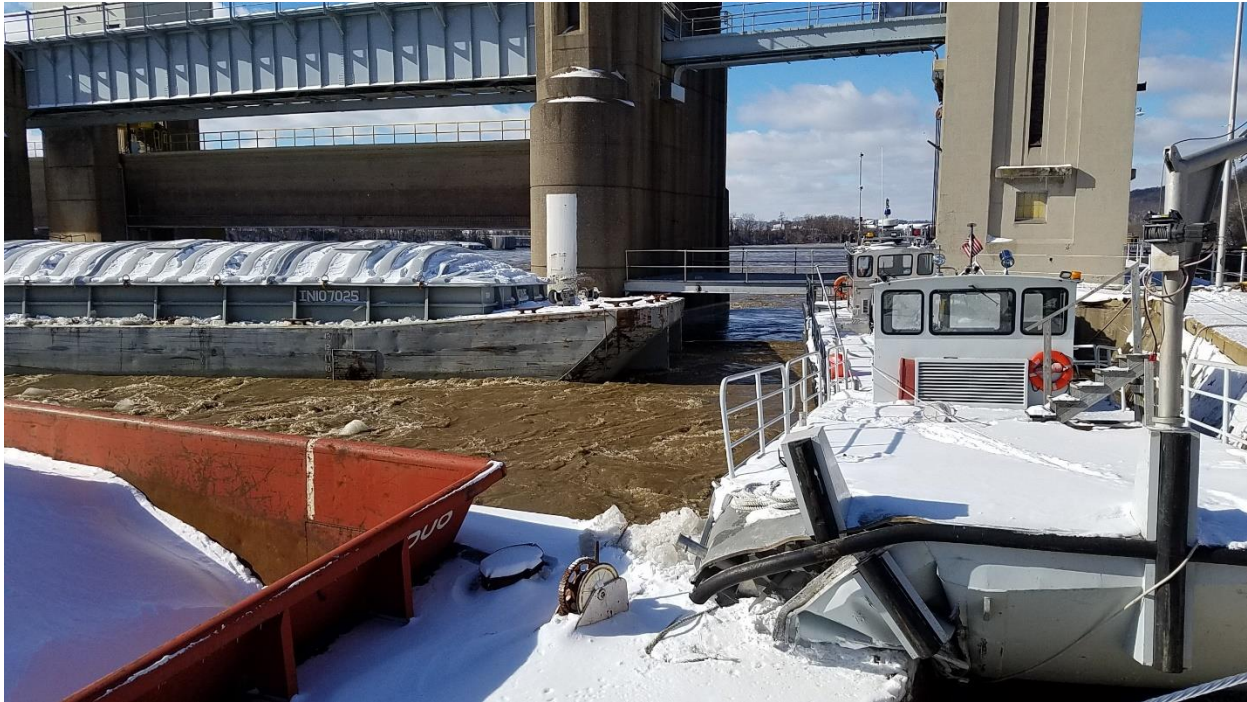
The accident resulted in the constructive total loss of both Corps of Engineers vessels, valued at \$690,404 combined. Seven barges were also lost, and all but one of the remaining barges required repairs. Damage to the barges, including lost cargo, totaled \$7.10 million. Salvage and other additional costs totaled \$3.99 million. According to the Corps of Engineers, the accident did not cause structural damage to the Emsworth Dams.

Stern of barge C508 after colliding with Corps of Engineers workboats *Emsworth* (foreground) and *Dashields* (background). (Photo by Coast Guard)

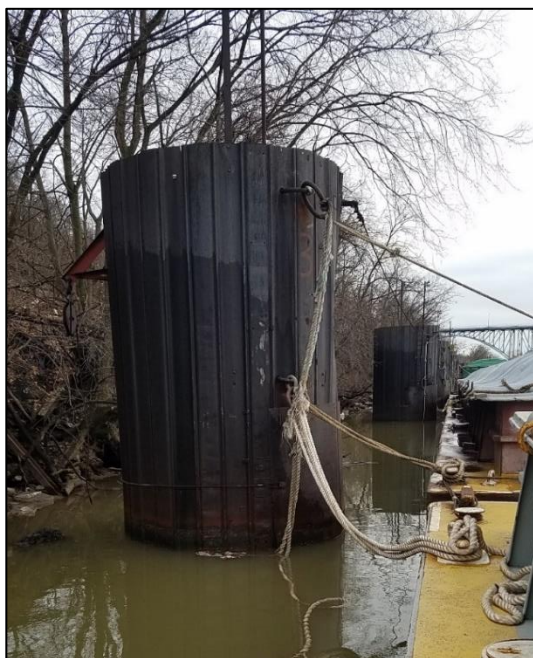
Mooring cell at the Jacks Run fleeting area. (Photo by Coast Guard)

According to interviews with both ALCOSAN and ITS, the mooring piles at the Jacks Run fleeing area were not being maintained by any of the parties using the fleeing area. Interviews with ITS and its contractors (MRHS, Borghese Lane) indicated that no one was clear on how to request repairs or who was responsible for those repairs. When an ITS senior manager was queried about the company's role in operations and maintenance of the Jacks Run facility, he stated, "We have no operational role. It's specifically laid out in our contract between Industry Terminal and McKees Rocks Harbor Services. They manage and operate the facility. They're responsible for the

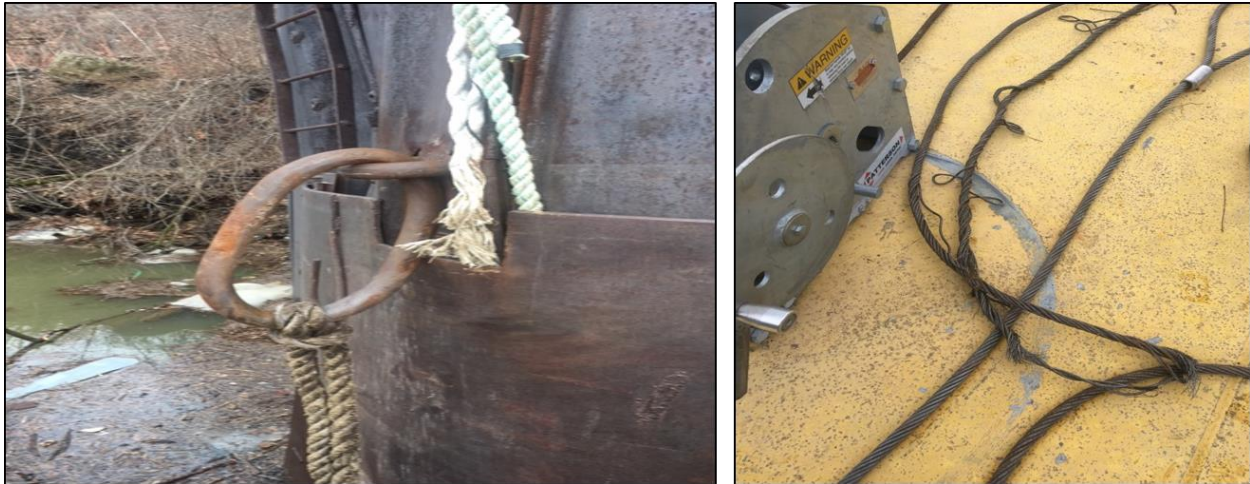
At left, a deformed anchor ring on third piling back from the forward piling. At right, parted and frayed mooring wires from the lead shore-side barge during the accident.

1. The breakaway of the barges at Jacks Run fleeting area occurred when the force of the river current acting on the extensive ice buildup at the front of the barge flotilla exceeded the capacity of the fleeting area's mooring cell fittings and the barge mooring wires.
