National Transportation Safety Board

Marine Accident Brief

Contact of Towing Vessel *Steve Richoux* With Mardi Gras World Pier

Accident type	Contact	No. DCA18FM022
Vessel name	<i>Steve Richoux</i>	
Location	Lower Mississippi River, mile 98, New Orleans, Louisiana 29°56.03' N, 090°03.50' W	
Date	May 7, 2018	
Time	About 1848 central daylight time (coordinated universal time – 5 hours)	
Injuries	None reported	
Property damage	>\$3 million est.	
Environmental damage	None	
Weather	Clear, visibility 10 miles, winds west 5.5 mph, air temperature 82°F, water temperature 64°F	
Waterway information	Lower Mississippi River at New Orleans. The river stage at the time of the accident was 12 feet and falling, with an estimated river current of 5–6 knots.

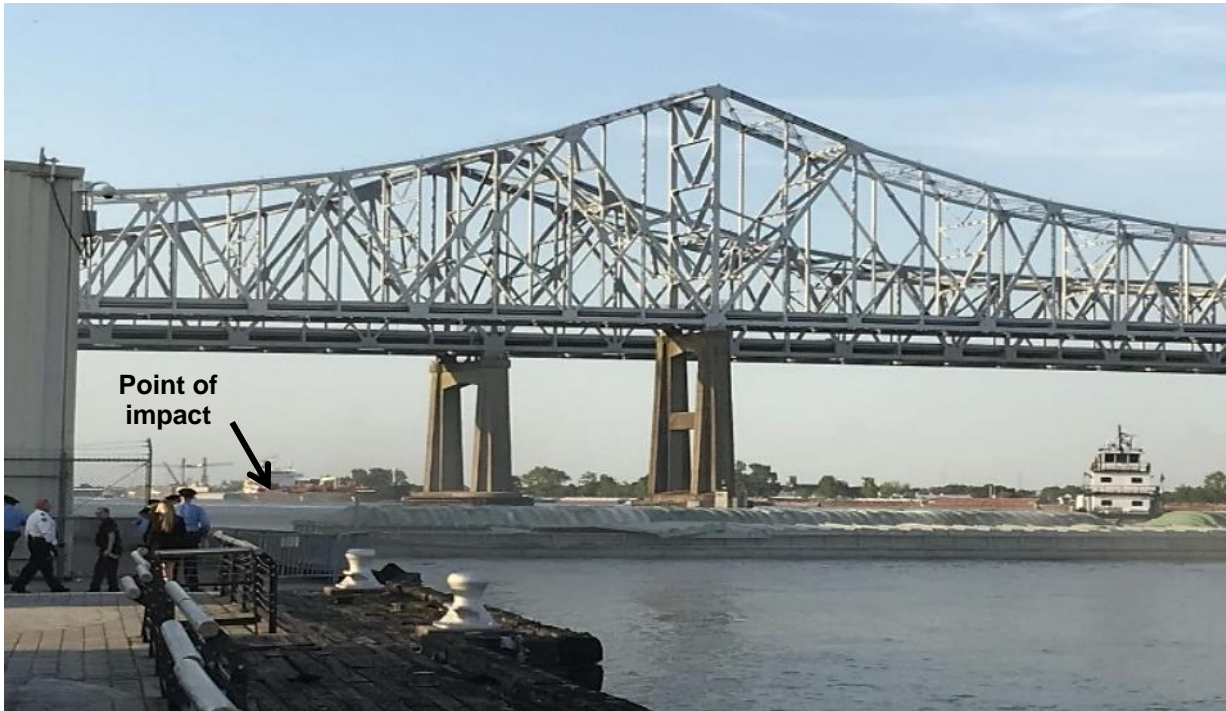
Before any assistance could arrive, the lead two barges of the tow struck the wharf at about 4 mph, causing significant damage to both the wharf and the Mardi Gras World warehouse. Two forward barges sustained minor damage; the *Steve Richoux* itself was not damaged.

Steve Richoux and barges after the accident (view downriver with the Crescent City Connection Bridges in the background). (Source: Mardi Gras World)

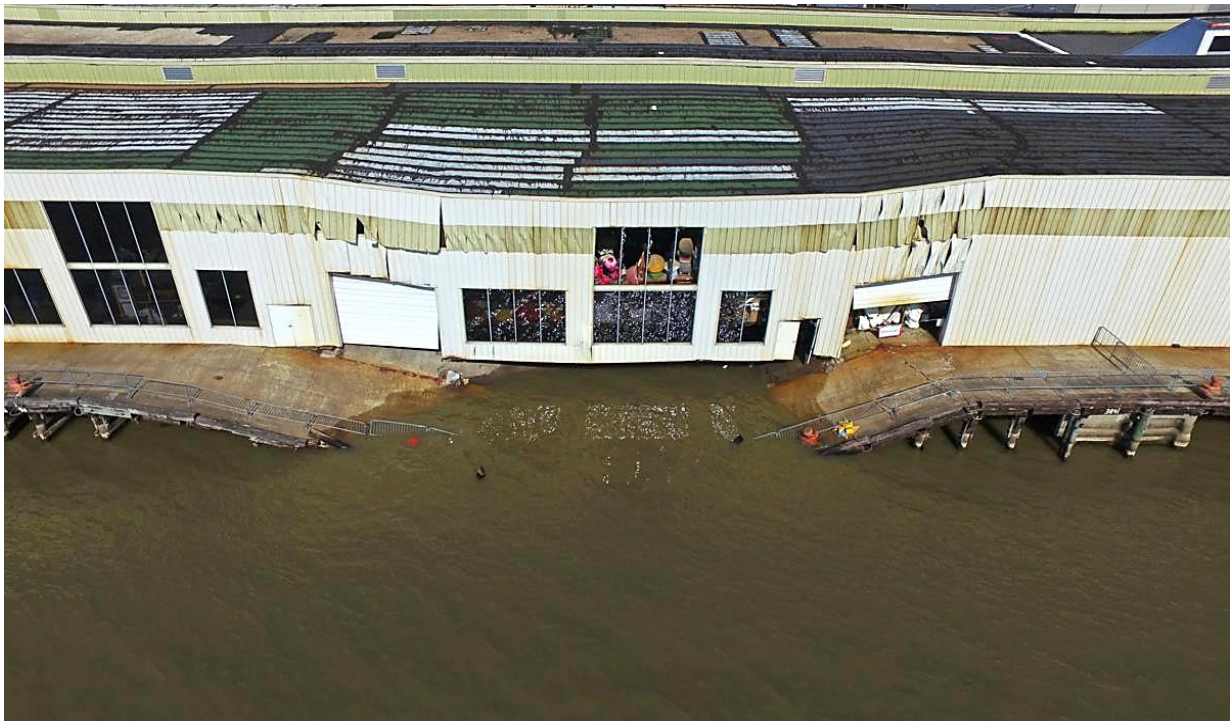
Damage to the Mardi Gras World warehouse and wharf. (Source: Coast Guard)

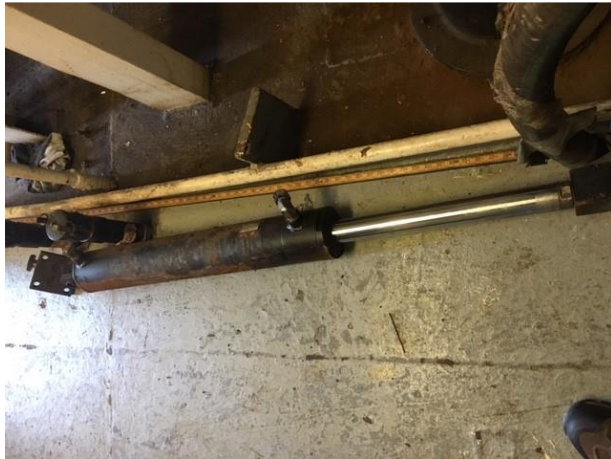
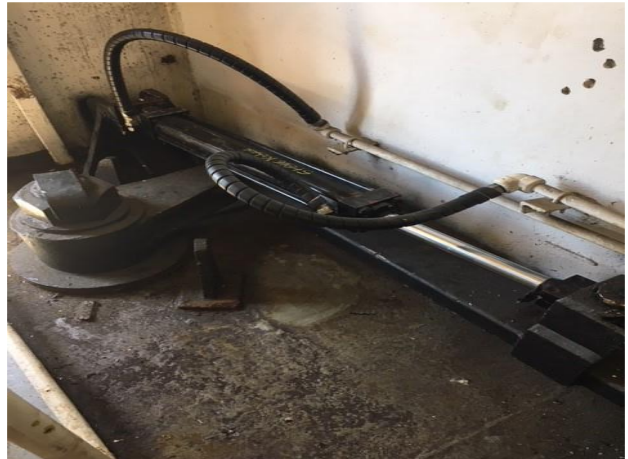
The service technician who tested and repaired the steering system postaccident found that the port flanking rudder actuating ram piston traveled an inch too far to the end of the ram, allowing the rudder to press up against the deck stops. This happened because the piston could extend farther than the distance the rudder could turn. Also, the limit cams that prevented the piston from traveling too far were not properly adjusted due to wear and did not stop the hydraulic supply when the rudder was in the hard-to-port position. This issue would have caused the system to over-pressurize if the flanking rudders were placed hard to port, as the hydraulic pump remained on-stroke and continued to generate hydraulic pressure.

Left, the port flanking rudder steering hydraulic ram that was removed after the incident. Right, the port flanking rudder steering system with the original steering ram in place.

The operational testing of the steering gear system following the 2017 drydock period would not have discovered the over-travel by the port flanking rudder's hydraulic ram piston, because the testing did not place the rams in the hard-to-port position long enough to over-pressurize the hydraulic system. In addition, the maintenance program and reporting system for the vessel was not effective because the crewmembers who had direct experience with the flanking rudder steering issue prior to the accident did not report related alarms to the company's maintenance personnel for repair.

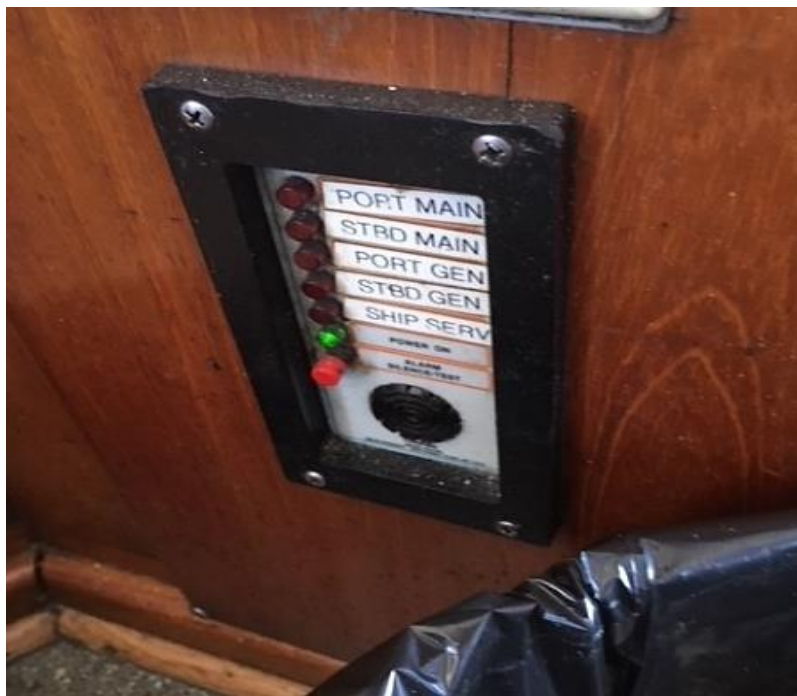
The system was designed so that, if over-pressure occurred, a hydraulic pressure relief valve would lift, protecting the fittings, piping, hoses, and pumps. The “SHIP SERV” alarm would also sound and illuminate in the wheelhouse. The service technician told investigators that this alarm indicated high hydraulic system pressure.

Alarm panel located on the starboard side of the wheelhouse near the deck. The alarm labeled “SHIP SERV” indicated that the steering system was over-pressurized.

According to a postaccident service report, crewmembers who regularly operated the *Steve Richoux* before the accident would receive intermittent alarms in the wheelhouse, which they would have to silence. The condition was never reported to the company's port engineer. The company's vice president of engineering also stated that during the daily vessel status briefs after the drydock period, no information was passed to the head office about the steering system not operating properly. After the accident, a service technician was able to replicate the alarm-activating condition and failure of the steering system by placing the flanking rudders hard to port.

who was in the wheelhouse cycled the steering levers for the flanking rudders hard to port several times in an effort to counteract the effect of the current as it moved the vessel from the river's right descending bank toward the left descending bank. Although the alarm listed as "SHIP SERV" activated and was silenced in the wheelhouse, neither the captain nor the pilot realized that its activation meant that the steering system was over-pressurized. Had the alarm been labeled as such, they would have known that the system had a problem.

Accurate labeling of alarms pertaining to critical machinery and essential systems is crucial so that vessel operators understand the nature of problems or failures. Quickly understanding what specific condition exists allows crewmembers and/or the operating company to take timely and appropriate action to mitigate or correct the condition.

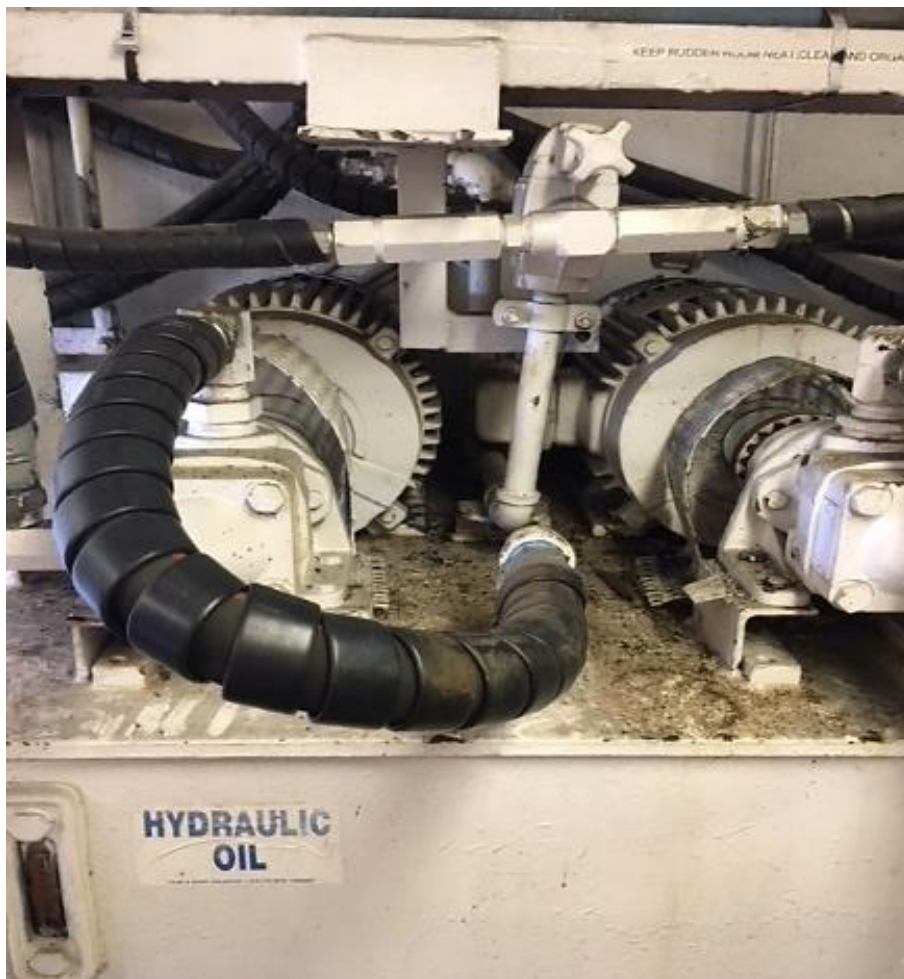
Because the actuating rams for the flanking rudders and main rudders operated off the same hydraulic system, if the port flanking rudder remained in the hard-to-port position and the relief valve continued to lift, the system would not hold normal operating pressure for the rams. Therefore, even if an operator switched between the two hydraulic pumps to maintain system pressure, the rudders would not respond to any additional commands because the relief valve was located on the

discharge side of the pump, preventing adequate oil flow from reaching the hydraulic pistons and developing the required pressure to move the rams.

Steering hydraulic pump motors that operated the flanking and main rudders.

The pilot and the captain tried switching the steering gear pumps to regain control of the vessel but doing so had no effect because the steering loss was caused not by the failure of a steering gear pump but by over-pressurization of the hydraulic system. Steering could not have been restored until the system pressure returned to normal. In an effort to control the vessel, the pilot's rudder commands included placing the flanking rudders hard to port, which unbeknownst to the pilot and captain was the source for the continued over-pressurized condition and subsequent continued lifting of the relief valve, which prevented normal system operating pressure from being restored. Had the captain or the pilot understood the cause of the steering failure, they would only have had to move the flanking rudders off the hard-to-port position to regain steering.
